# How To Improve Your RV's AC Airflow

by Gary L. Mace

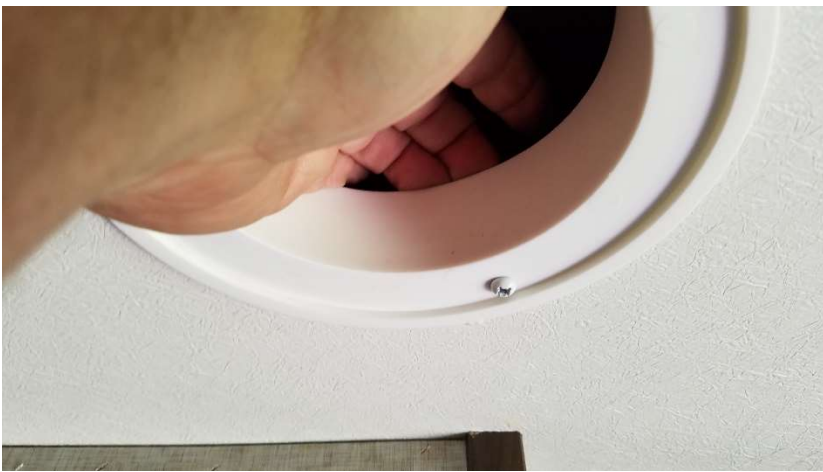
When I removed the vent cover which exposed only the cover housing, it would be easy to miss the problem. But once you feel around as I did in the photo, you will likely find several large gaps between the plastic housing and vent duct. Here I can fit my fingers in the gap. The next photo will show better the problem.

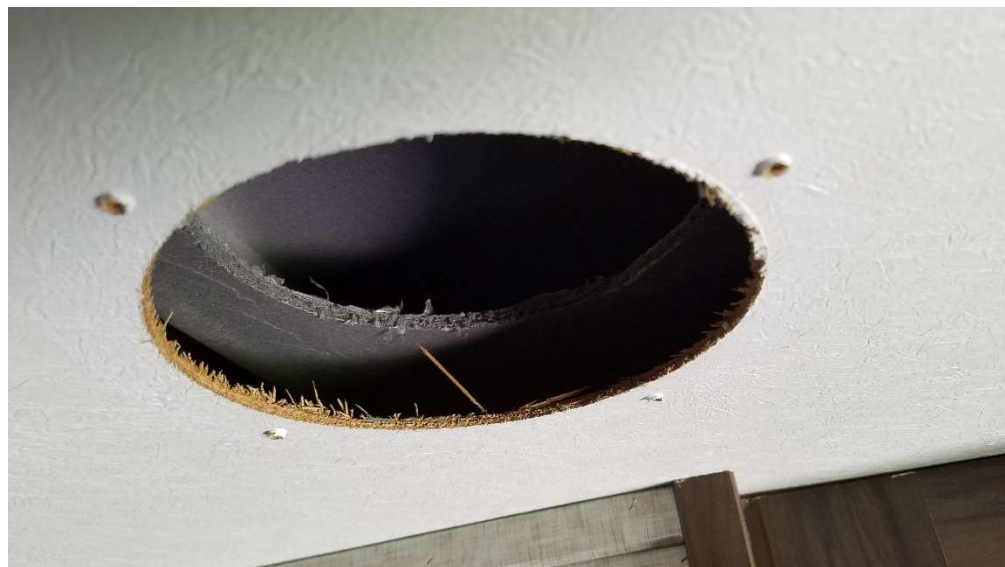
Once the cover housing is removed, if this is what you see, you also are likely losing air flow between the ceiling and the roof. The lower hole is in ceiling and the upper hole is in the bottom of the ac vent ductwork. Quite often they do not align properly, and the housing will not make a tight seal with the upper hole. This allows much of your cold air to leak into the ceiling void.
